One Year Since the High-Rise Fire in London

– What the Grenfell Tower fire alerted us to –

Ai Sekizawa

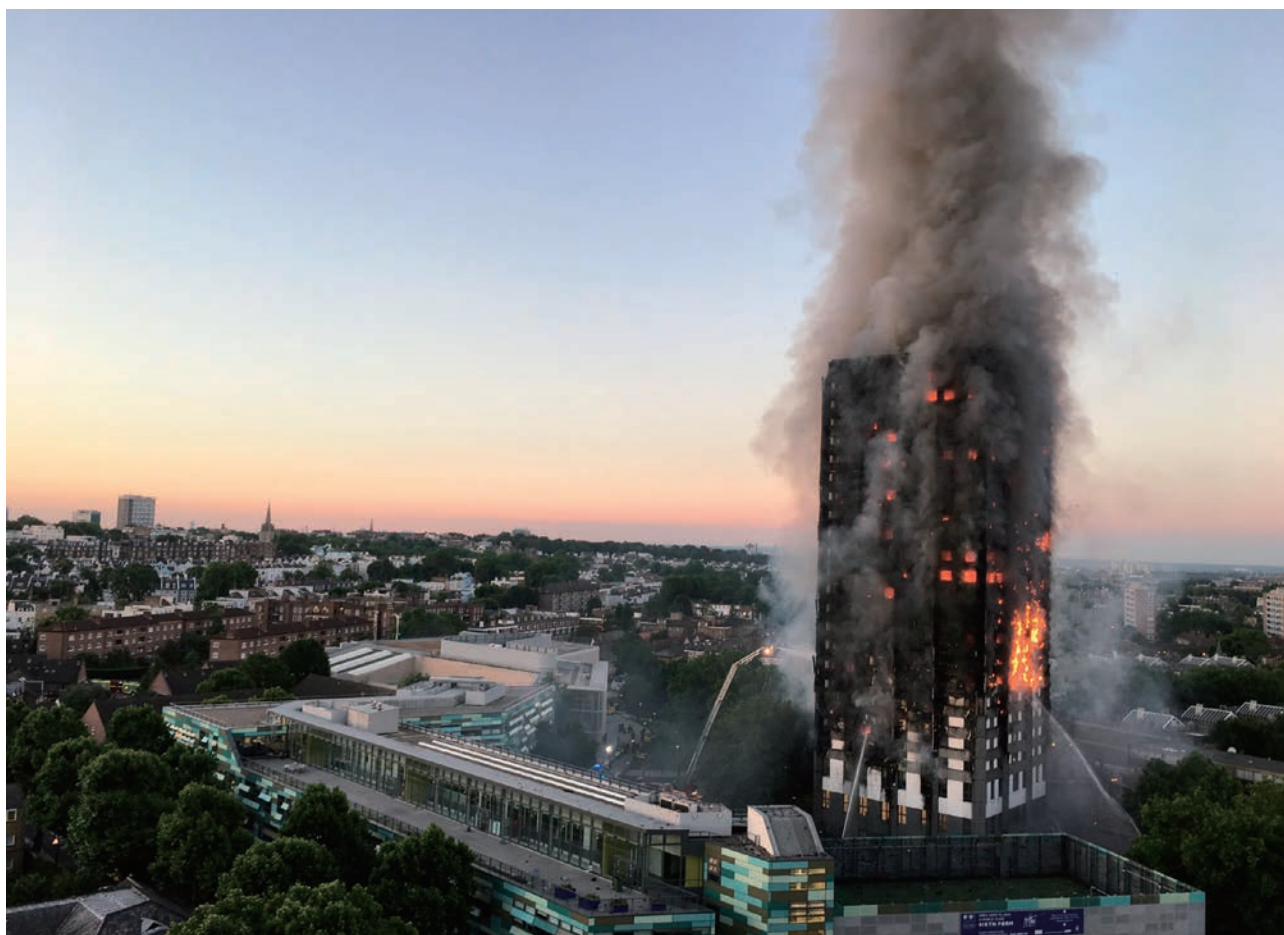
Photo 1. Grenfell Tower in flames up to the upper stories

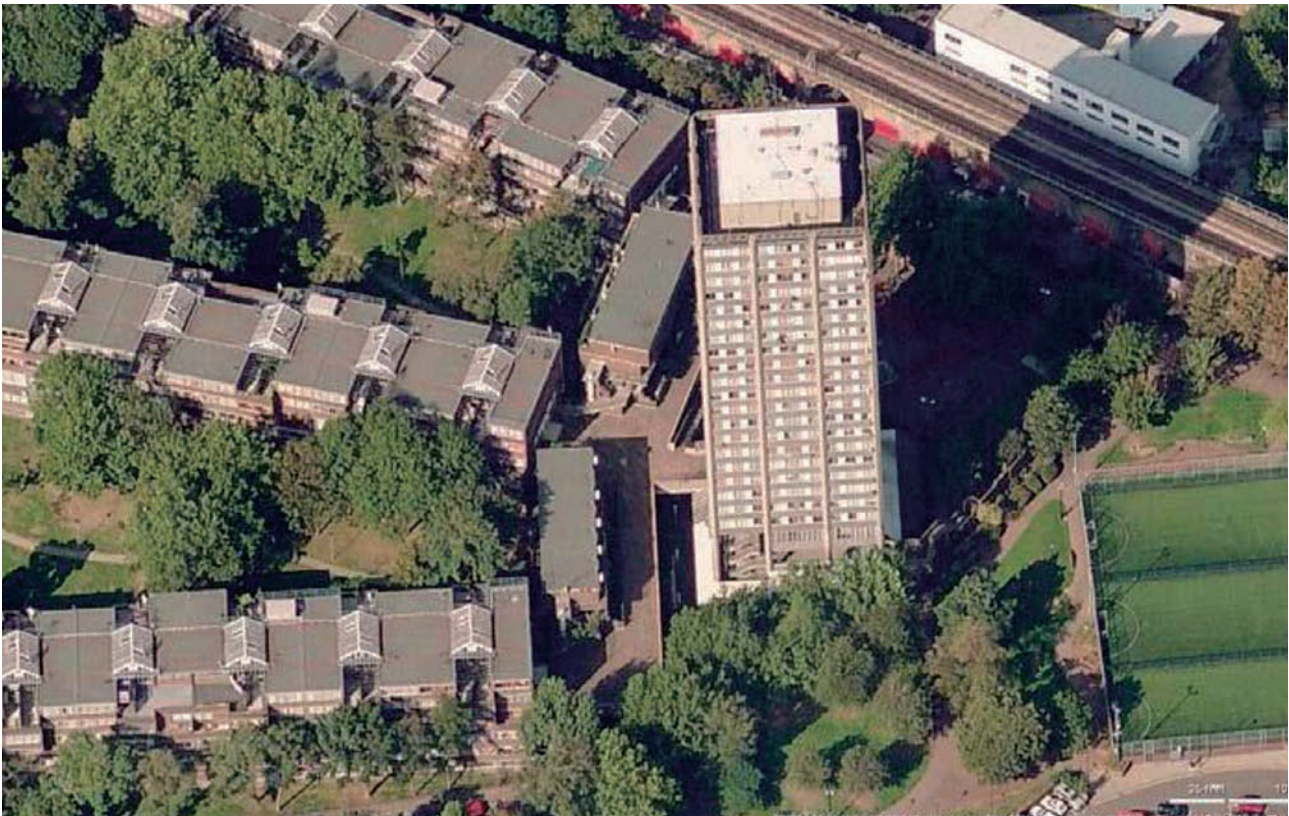
Figure 1. Full view of Grenfell Tower before the fire

Note. The fire started on this side (the east façade) on the building's eighth floor above ground in the photo and spread upward.

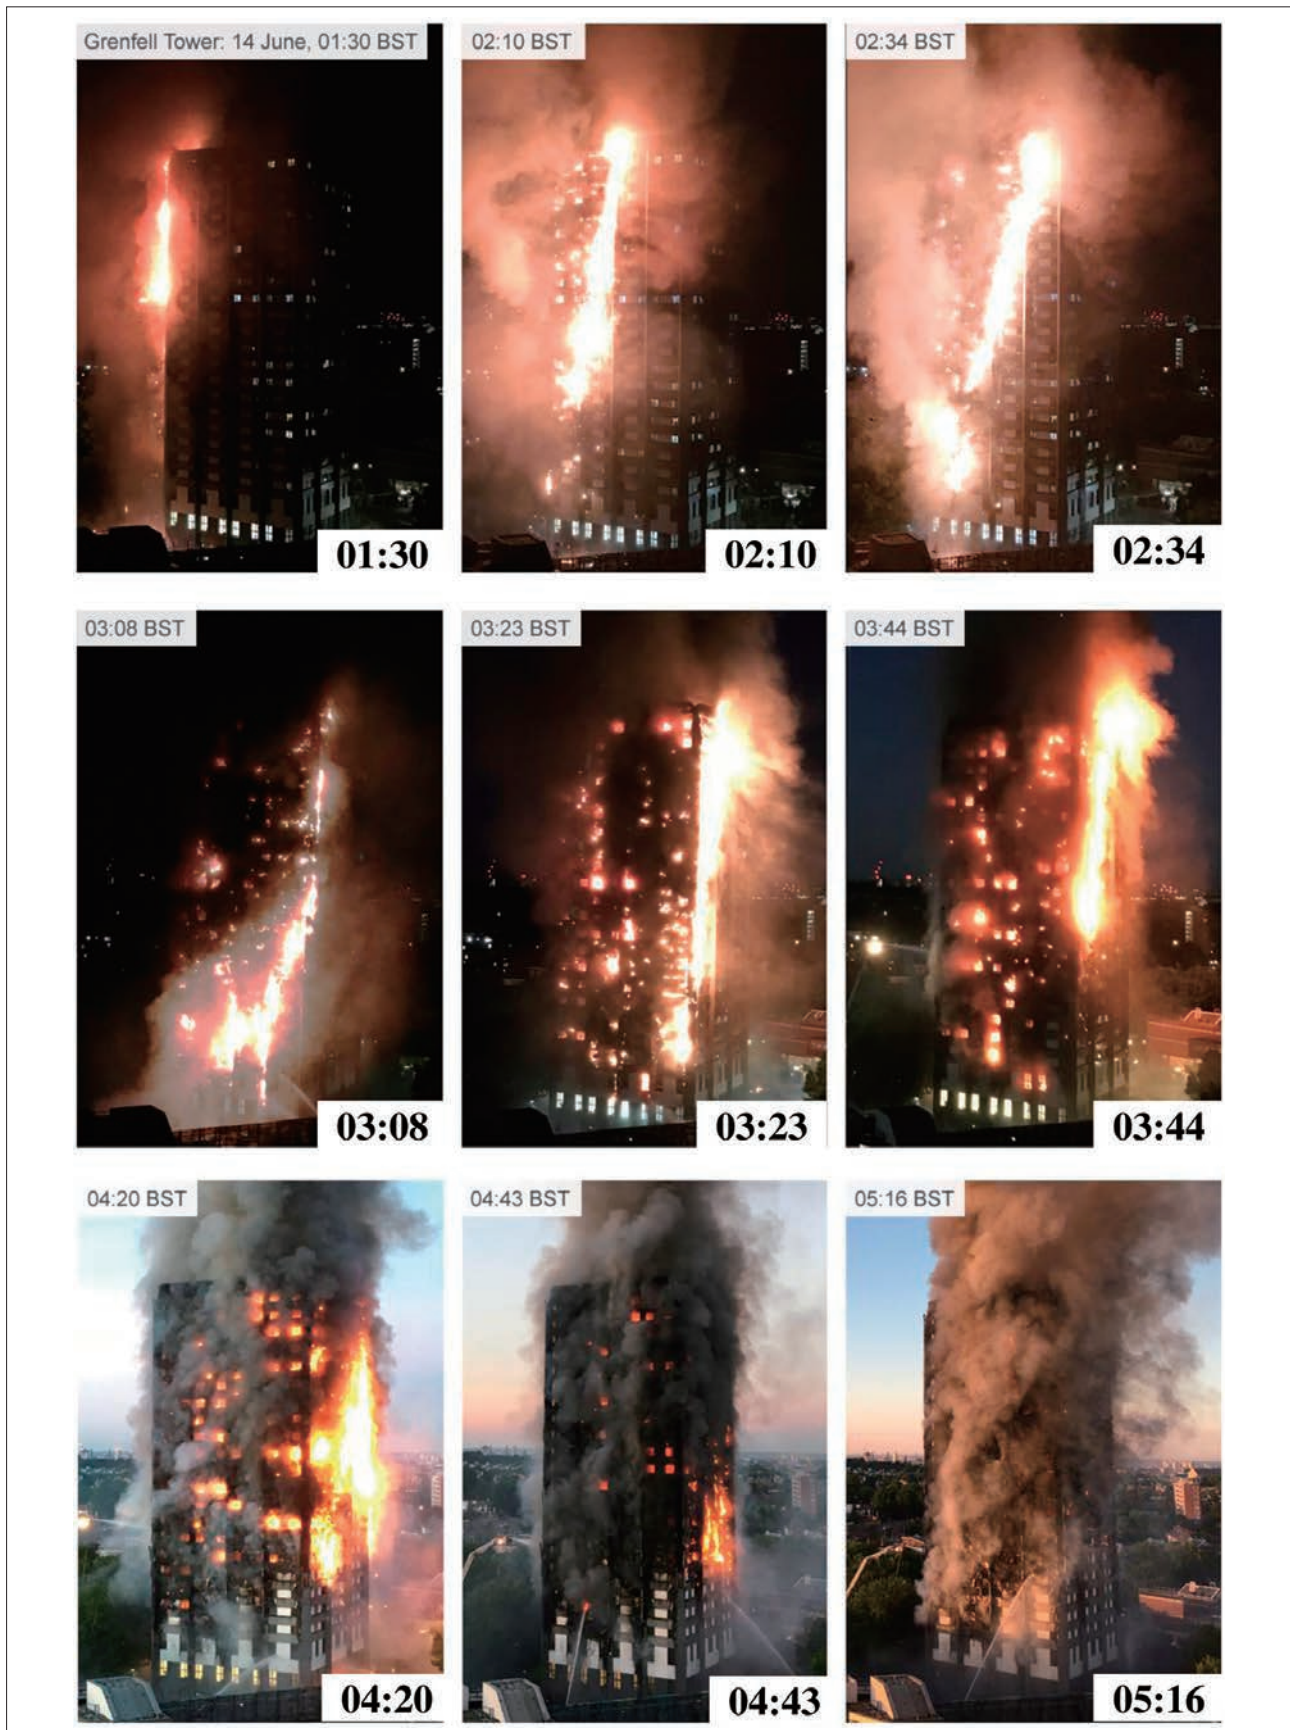
Figure 2 shows photos from the BBC News site,³⁾ which demonstrate the process of the exterior wall surfaces burning and the upward fire spread in the Grenfell Tower fire. These photos were probably taken from the northwest corner side of the building. The fire started in a dwelling unit on the eighth floor on the opposite side (northeast corner) to the shooting position. From the photo taken at 01:30, about 30 minutes after the start, it can be seen that the flames along the exterior wall have already reached the top floor though that cannot be squarely

Figure 2. Conditions of the fire spread over the exterior wall surfaces in the Grenfell Tower fire
Source: 3) BBC News (London fire: A visual guide to what happened at Grenfell Tower)
<http://www.bbc.com/news/uk-40301289>

seen. The fire spread over the wall surface was soon propagated to the north façade and to each wall surface in the pattern of an upward fire spread like a fan in the upward direction.

In the photo taken two hours after the start of fire (at 03:08), the flame has spread to almost the entire north façade. About three hours later (in the photo taken at 04:20), fire was also spreading over all of the west façade. From the photos after the fire had been extinguished³⁾ (Figure 3), showing the conditions of the upward fire spread, all of the section of the fourth and higher floors above ground at the northeast edge, where the fire started on the eighth floor above ground, has been completely burned, while it appears that the fire spread did not reach part of the south side, west side and east side on the tenth and lower floors above ground. Depending on each dwelling unit's position on each floor or story, the danger level and the easiness of escape seem to have varied.

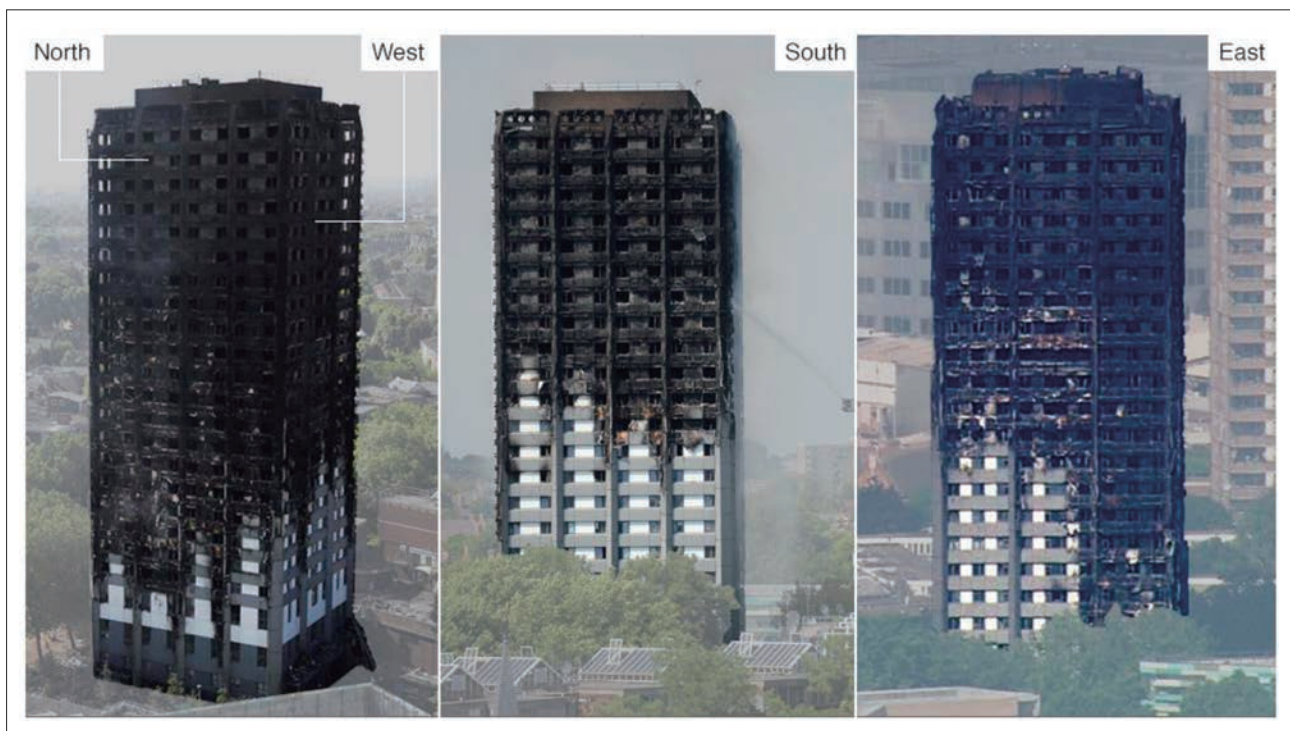
Figure 3. Condition of the exterior wall surfaces of Grenfell Tower after the fire
Source: 3) BBC News (London fire: A visual guide to what happened at Grenfell Tower)
<http://www.bbc.com/news/uk-40301289>

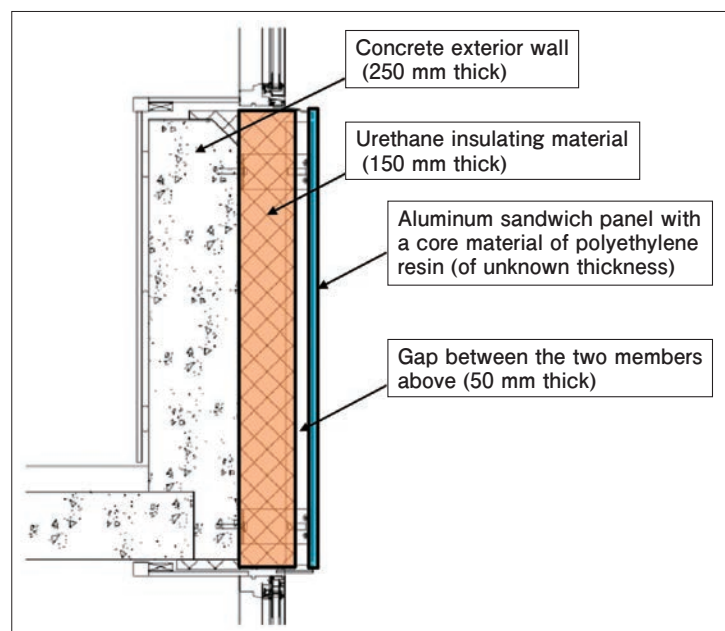
The diagram of Grenfell Tower’s exterior wall area in a document from the Grenfell Tower owner, the Royal Borough of Kensington and Chelsea⁷⁾ is shown in Figure 4. A layer of 150-mm urethane insulating material (orange part in the diagram) covers the outer side of the concrete exterior wall (250 mm thick), and an aluminum sandwich panel with a core material of polyethylene resin is set as the outermost exterior material for weather protection (blue part in the diagram). Between the urethane insulating material and the sandwich panel, there is a 50-mm gap to prevent dew condensation, but the surface of the urethane insulating material was just covered with aluminum foil and lacked a metallic covering. It is supposed that this weakness was exposed to the ejected flames from the window of the dwelling unit where the fire had started and allowed the flames to rapidly penetrate, causing the urethane insulating material to catch fire and burst into flames, which led to the rapid upward fire spread.

Figure 4. Cross-section showing the insulation status of the exterior wall face
Source: 7) Grenfell Tower Regeneration Project – Sustainability and Energy Statement
Note. A layer of 150 mm urethane insulating material (orange part) covers the outer side of the concrete spandrel wall face.

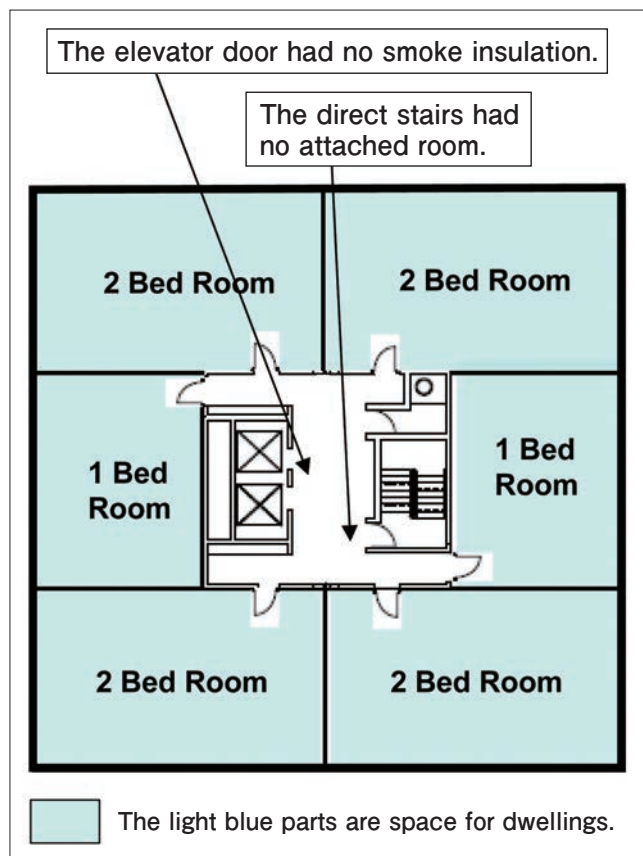
In addition to the speed of upward fire spread, it would be necessary to mention evacuation problems in this fire. Figure 5 shows the floor plan of a standard dwelling floor in Grenfell Tower. From this floor plan, it can be seen that this high-rise apartment building has just a single staircase that functions as an escape route and no balconies which can be used for another escape route. Furthermore, both the staircase and the elevator shaft face the central hall, and there is no attached room to a staircase that functions as a buffer zone from smoke penetration. Therefore, in this fire, the currents of smoke and heat from the room where the fire started, running off to the shared hall at the center of the floor, flowed into the staircase at a very early stage, which would have got in the way of any escape.

Figure 5. Floor plan of a standard dwelling floor in Grenfell Tower (This figure was made based on the plan shown in the Grenfell Tower Regeneration Project.)
